5TH INTERNATIONAL CONFERENCE ON

Timber Bridges

Rotorua, New Zealand • 29 June – 2 July 2025

Conference Programme

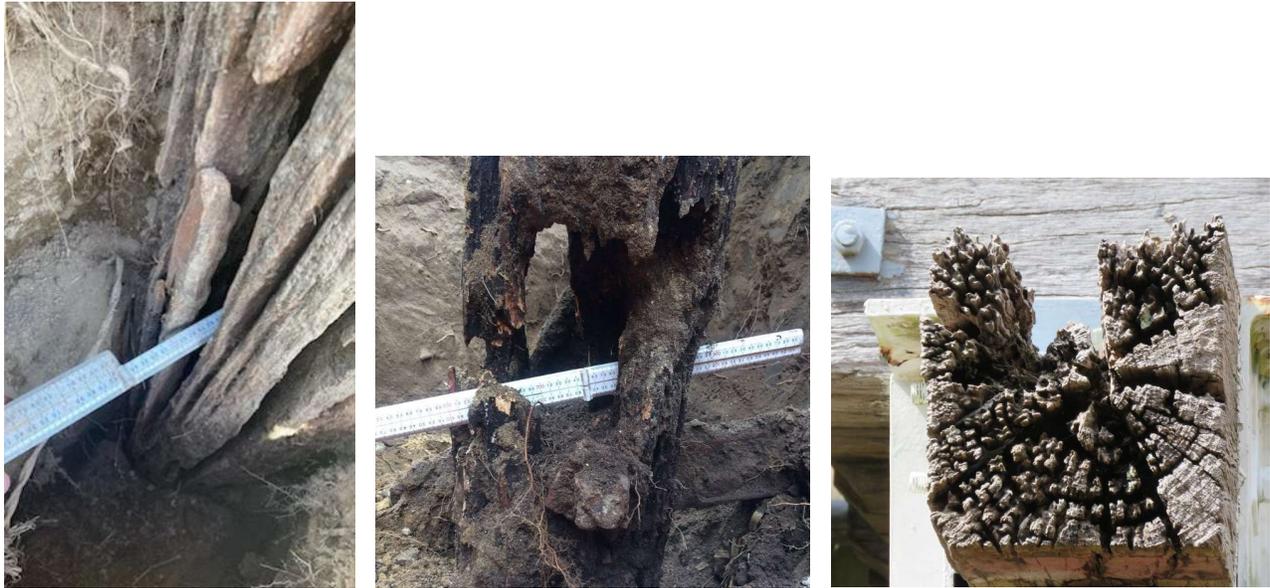
Figure 1: Examples of defects observed in the field in timber pile and beam elements.

Degradation of timber members manifests itself in many ways. Examples of defects observed in the field are illustrated in Figure 1.

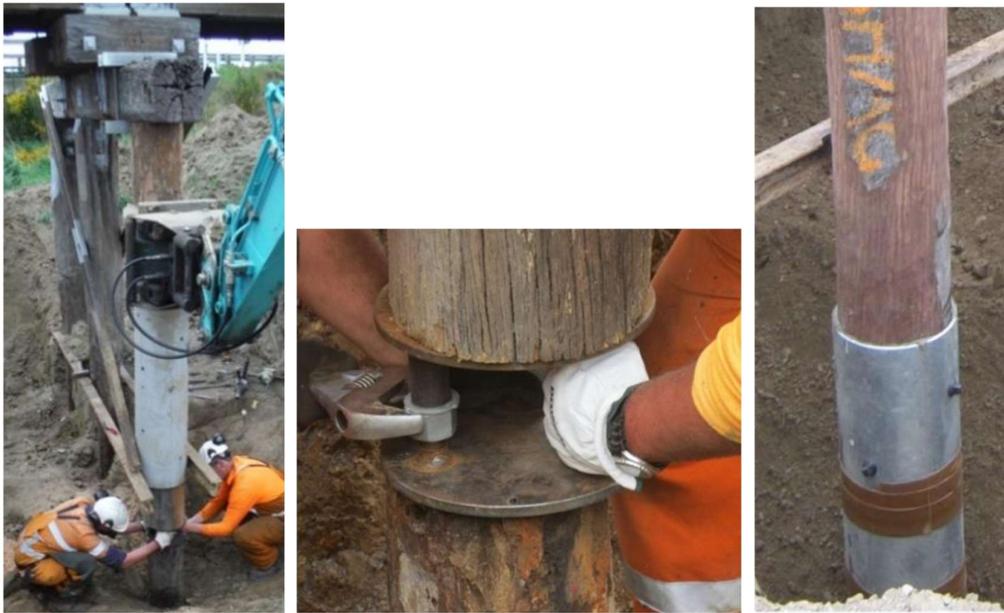
Figure 3: Current process for installing a stump repair.

- Placing steel clamps on beams and pile caps (refer to Figure 5).
- Removing a section of a timber pile and reinstating with a new section (stump repair). This approach has evolved from solutions such as the examples in Figure 2 where the new and old sections were spliced together using steel members and bolts, to the current approach shown in Figure 3. The current approach introduces a compression force into the new and old sections using a simple bolted jack. The stump jack is then wrapped with a steel jacket (sleeve or split cylinder) and filled with concrete or high strength grout as shown in Figure 3 and Figure 9.
- In addition to its application in stump repairs, the split cylinder method can also be applied to an in-situ single timber section with defects.

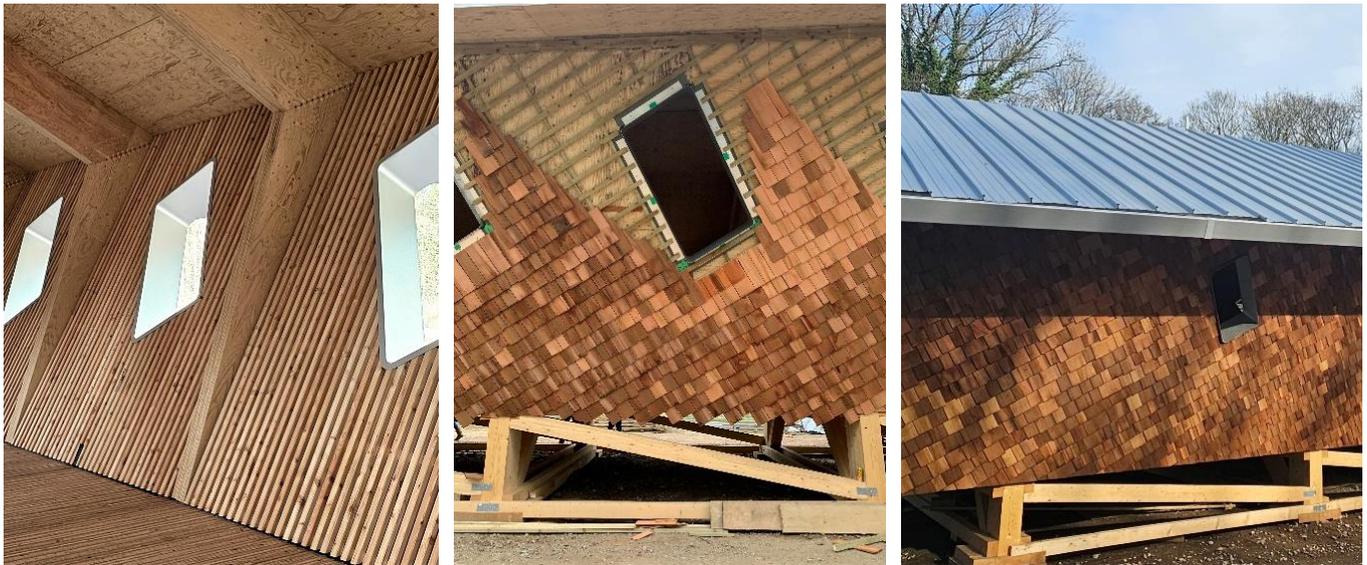
Figure 3: Finishes of deck, façade and roof

- The roof is clad with aluminium panels, providing robust protection against the elements.
- With a usable width of 6 meters, the walking surface on the bridge deck is constructed from wooden larch planks with anti-slip grooves to enhance safety.
- The inner surfaces are lined with a secondary structure of larch slats. This secondary layer, commonly used in wooden bridges, protects the main structure and can be replaced if necessary. In addition, the non-planar surface design helps to deter graffiti, as the irregular texture makes it difficult to apply and maintain graffiti.
- The façades are covered with Western Red Cedar shingles. This traditional wood tile technique provides effective protection for the GLVL panels while maintaining the natural, warm appearance of timber.

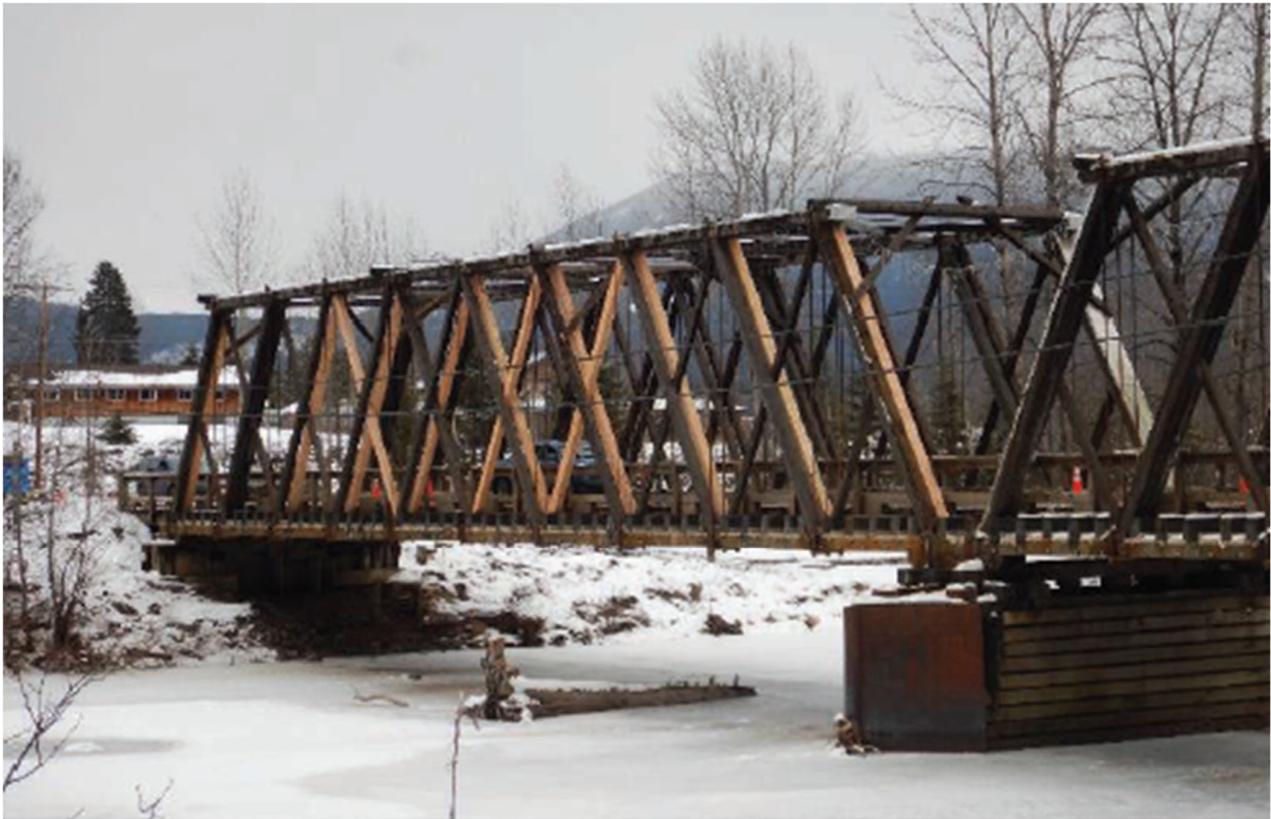
Figure 16 Completed Repairs

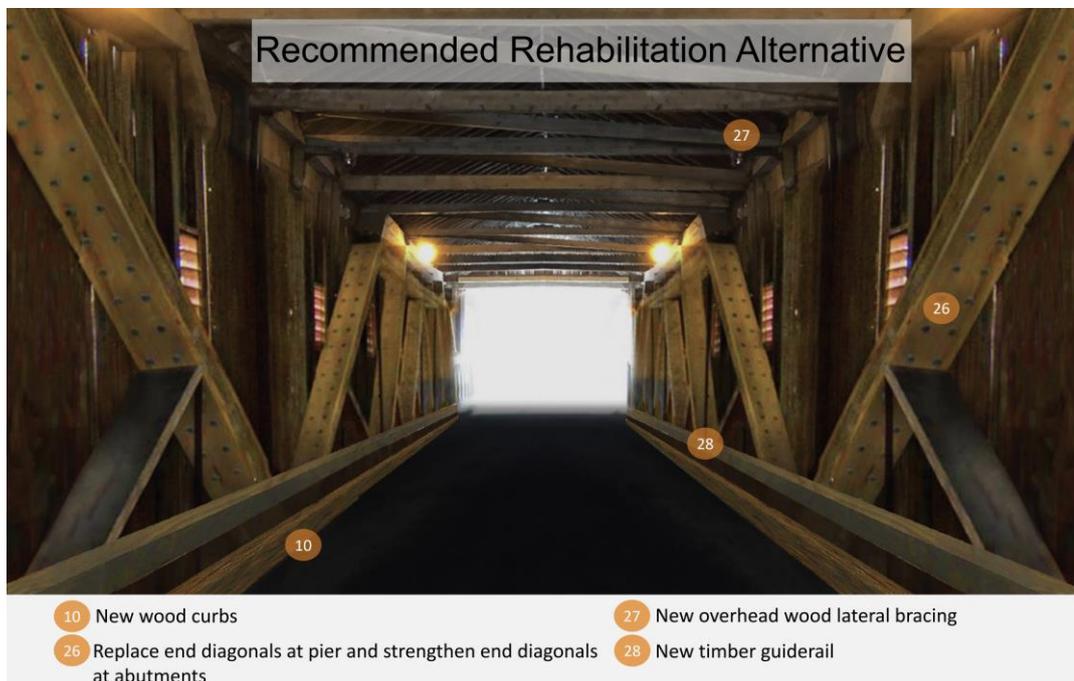
Figure 10. Rendering of Alternative C2

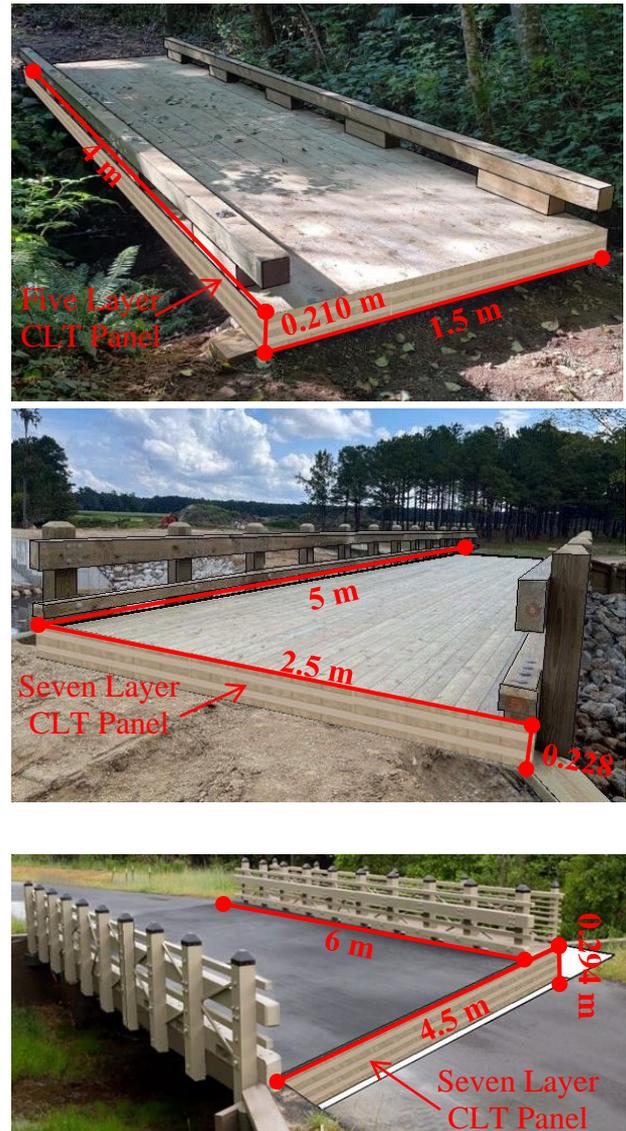
Figure 2. CLT panel application for short-span bridges.

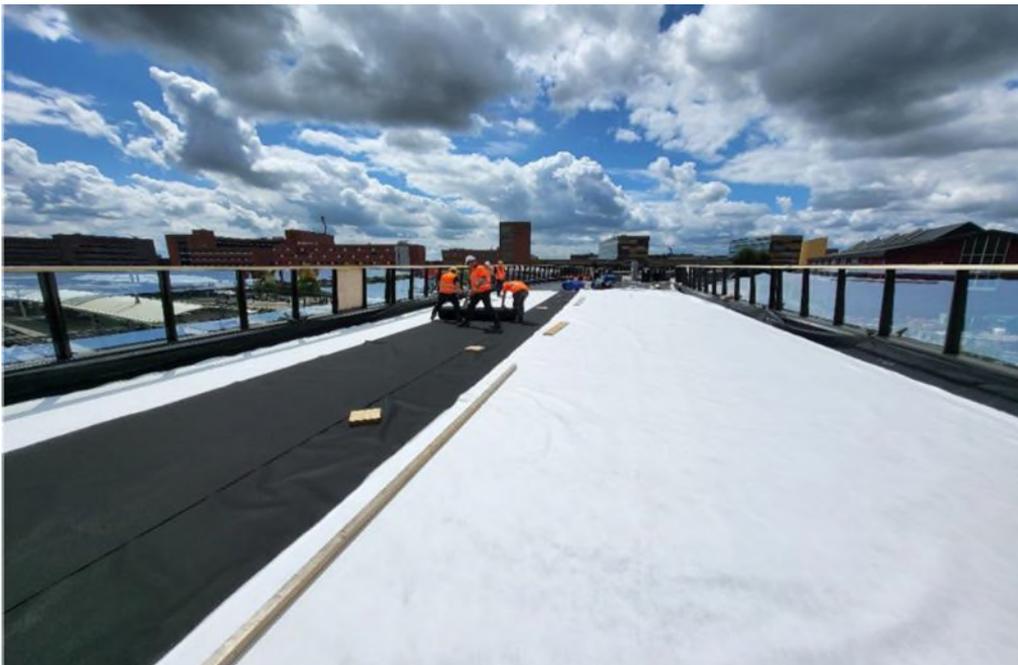
Figure 10: Installation of waterproofing with integrated full area leak monitoring

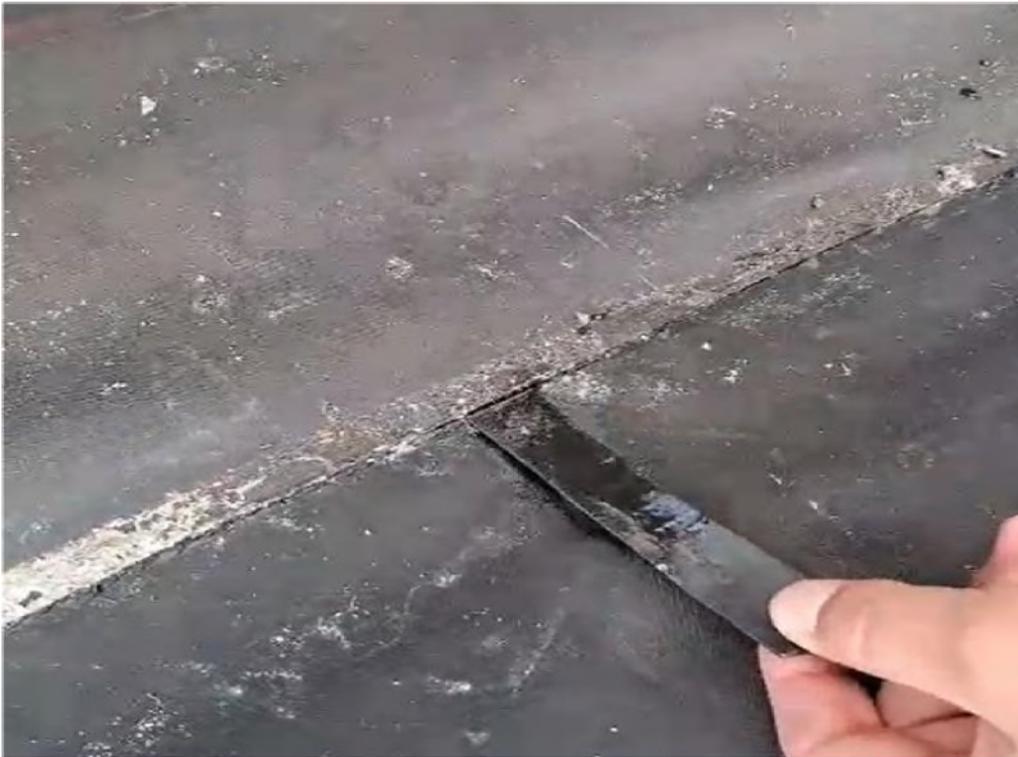
Figure 14: membrane leak identified and found with the installed full areal real-time monitoring system

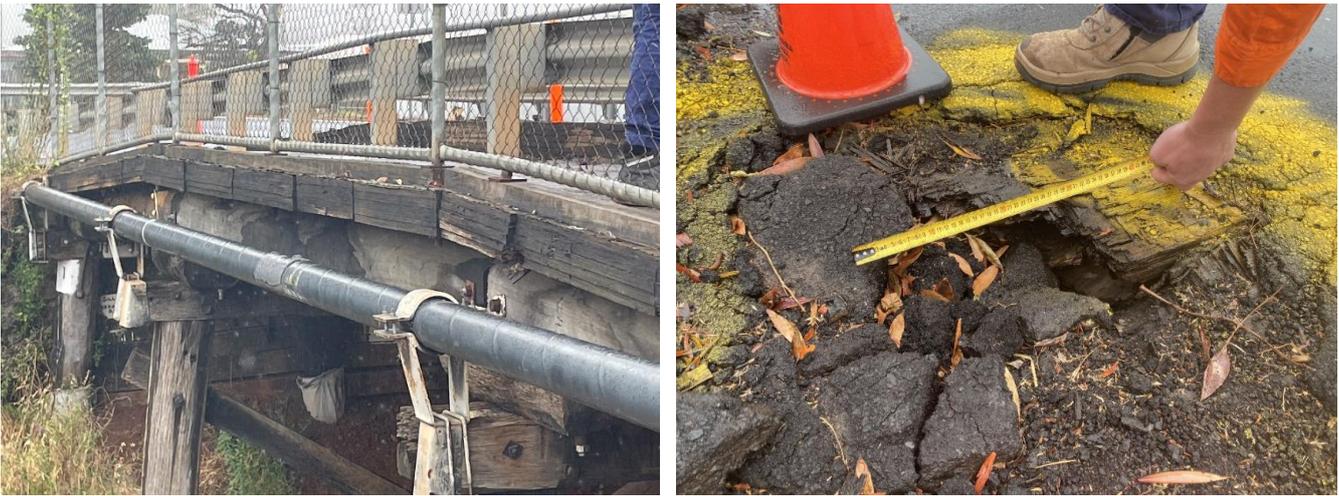
Figure 2. Drayton Rail Overbridge elevation and deck issues

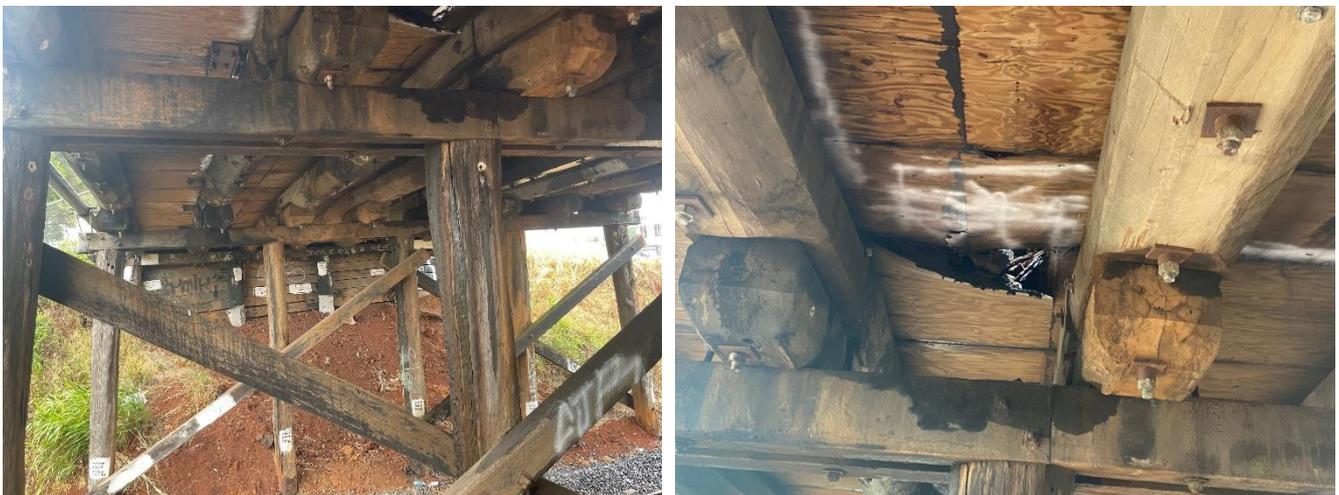
Figure 3. Rotten plywood deck sheeting at Drayton Rail Overbridge

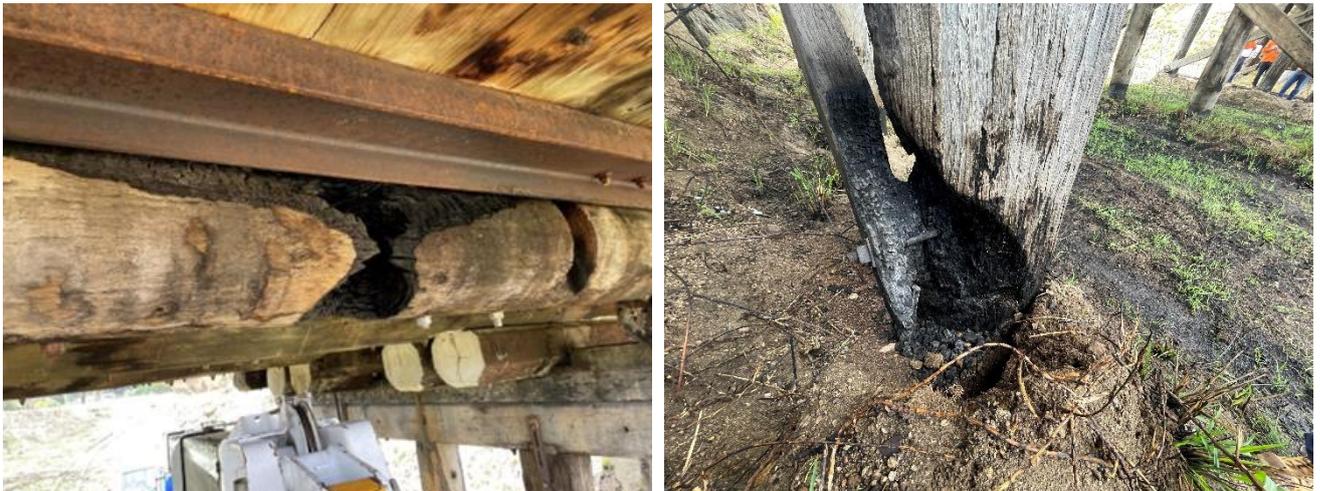
Figure 6. Fire damage (Mid Span Girder left, Pile right) at Wallangarra Rail Overbridge

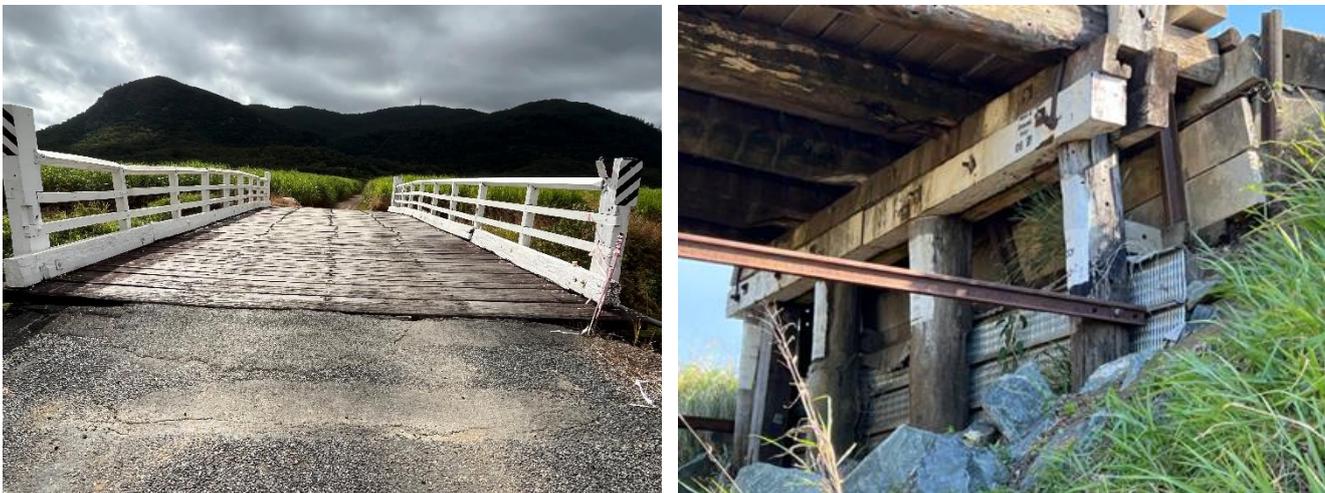
Figure 8. Approach settlement and abutment sheeting failure at Hopes Road Rail Overbridge

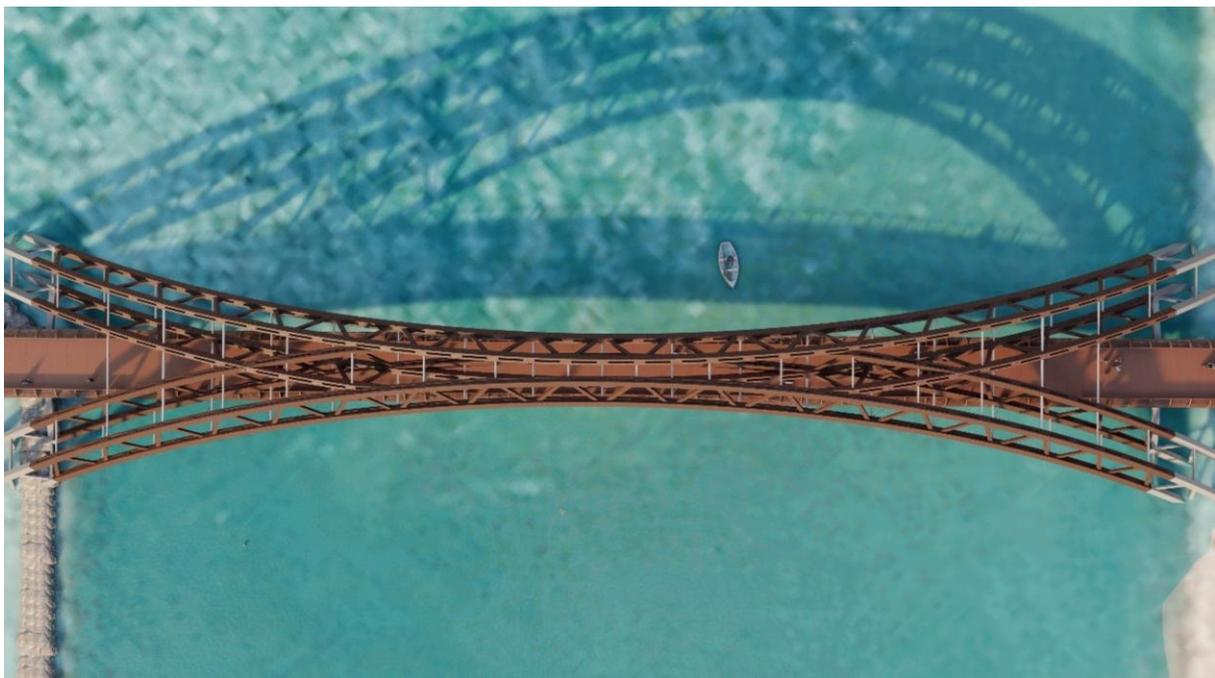
Figure 4 – Plan view of the bridge

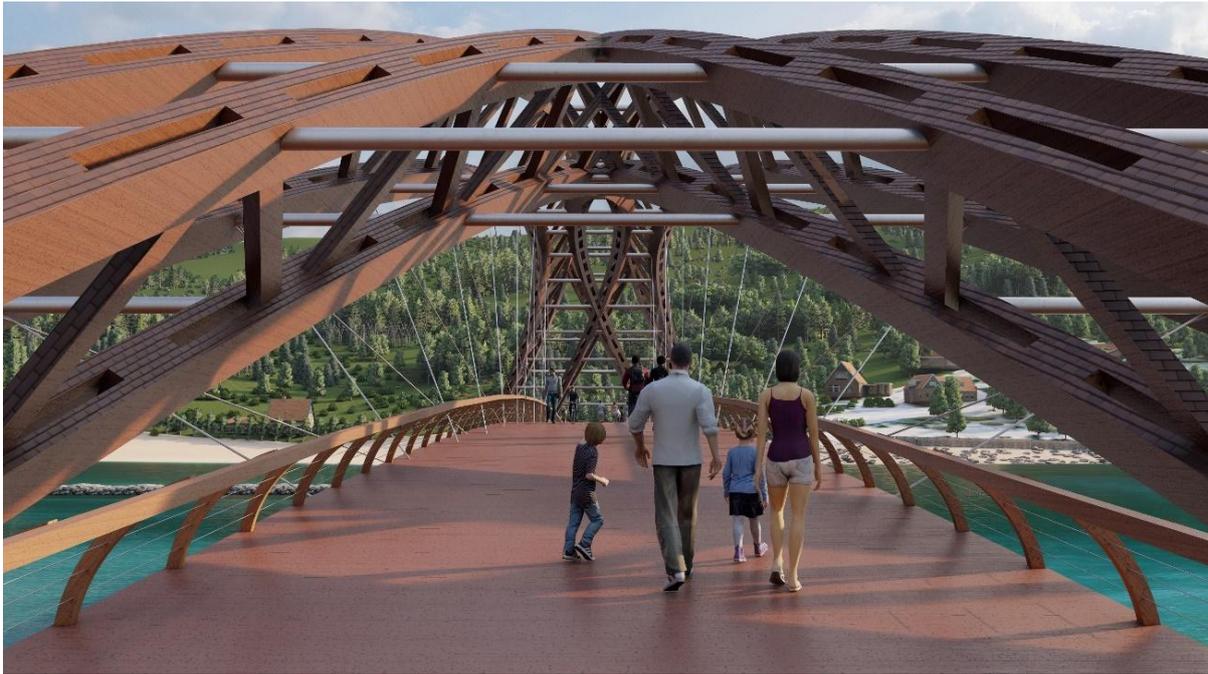
Figure 7 – Cross-sectional view
